***In this section technical director Perryn Leech reviews the Wales Millennium Centre, the home of Welsh National Opera. He is followed by production director Gerry van Hezewyk on the Esplanade in Singapore and architect Tony Stafford describing the development of the Leicester Performing Arts Centre.***

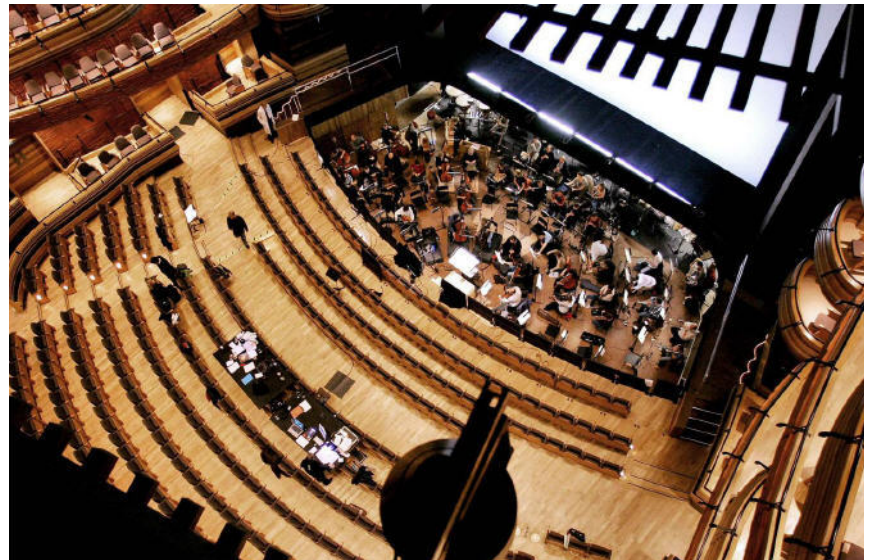
*Bird's eye view of a rehearsal in the main auditorium, showing the production desk and the normal size orchestra pit*

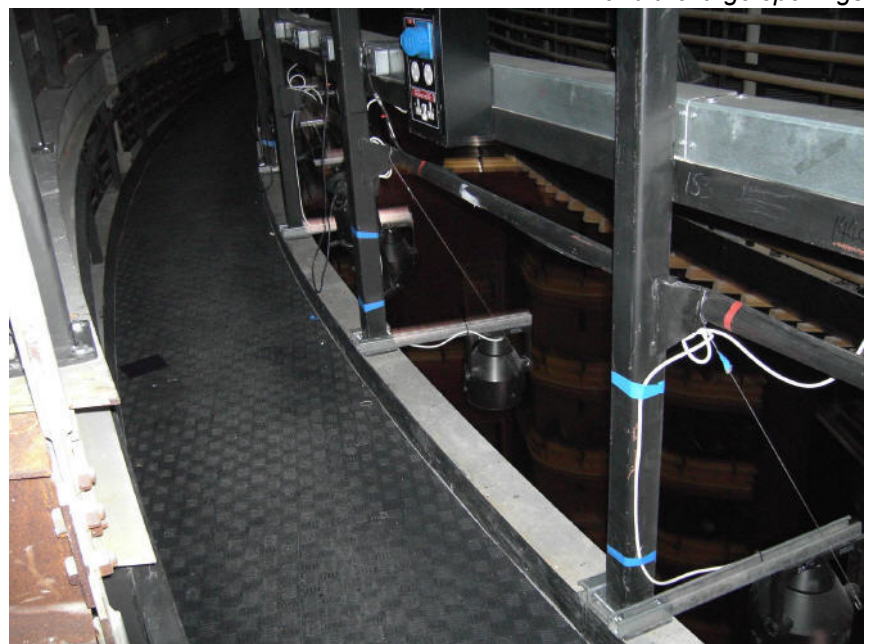
Now we move on to the minutiae! Ninety percent of the front-of-house lighting bridge is very good, well thought out and very clever. The PAR fittings that are shown in the picture pull up and can be changed from the lighting bridge which has a suitable kick edge and anti-slip surface. However, even a person of my size can fit comfortably between the lighting bar and the kick edge. It almost defies belief that in this day and age that a 4-ft (1.2-m) high gap should be unprotected under the lighting bar. We asked for a safety-harness line to be put in along the back of the bridge so that people could be harnessed, but that has not been installed because it is not considered to be a major problem. This is the politics of being a tenant in the building; primarily the resident building staff are focused on front-of-house matters and ultimately it is their call. My staff don't go up to the bridges very often, so it is best for me to leave the building managers to resolve this issue.

*Auditorium lighting bridge showing the lighting rail and the large openings*
